# MicroROV Technology Helps in *USS Arizona* Preservation

## By: Bob Christ

ROVs are forging ahead in fragile and hazardous – even sacred – environments that divers dare not tread. The 8-pound VideoRay ROV took a leading role delivering instruments and video cameras into the *USS Arizona* with the National Geographic Society and the US National Park Service in September, 2000 and June, 2001.

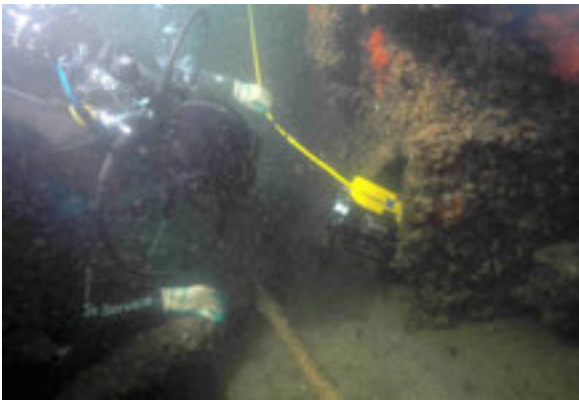
VideoRay entering air shaft at stern just forward of peak of stern (Photo by Brett Seymour, NPS)

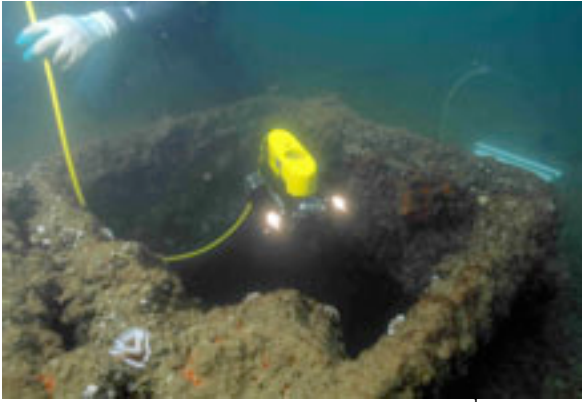
VideoRay entering hatch penetrating into 3<sup>rd</sup> deck for oil analysis and metal corrosion analysis (Photo by Brett Seymour, NPS)

On the 2<sup>nd</sup> expedition to the *USS Arizona* in June, 2001, a more thorough and systematic analysis of all accessible areas within the wreck was planned and executed. During review of the tapes from the first expedition, an open hatch to the 3<sup>rd</sup> deck from the second deck was discovered. Penetration into the 3<sup>rd</sup> deck living quarters was made with progress all the way to the stern water-tight bulkhead. A systematic survey of all living quarters and common spaces was made on the 2<sup>nd</sup> and 3<sup>rd</sup> decks. A penetration was made through the #3 barbette down to the first platform to survey the oil bunkers for structural status.

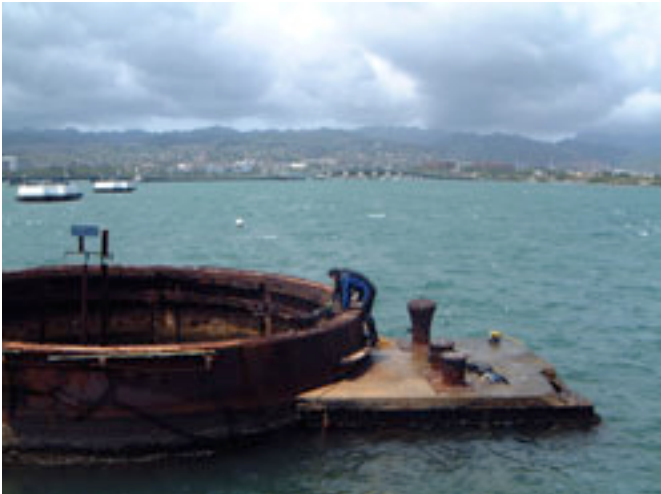
Larry Murphy of the NPS preparing to tend tether for VideoRay inside of Barbette #3 (Photo by Bob Christ)

Techniques were worked out between NPS divers tending tether and VideoRay surface operations aboard the memorial. Specifically, divers would meet the sub and lead it to the penetration area then slack and pull tether to allow for easier penetration. Divers could assist in un-fouling tether snags, help pull tether around corners and monitor the progress of the dive.

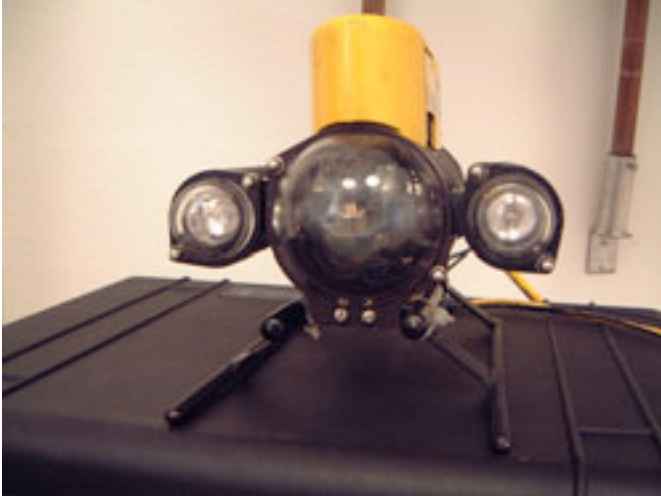
A dissolved oxygen probe was attached to VideoRay and flown through several points within the hull.

VideoRay with Dissolved Oxygen probe attached on the bottom of the starboard-side hull (Photo by Bob Christ)

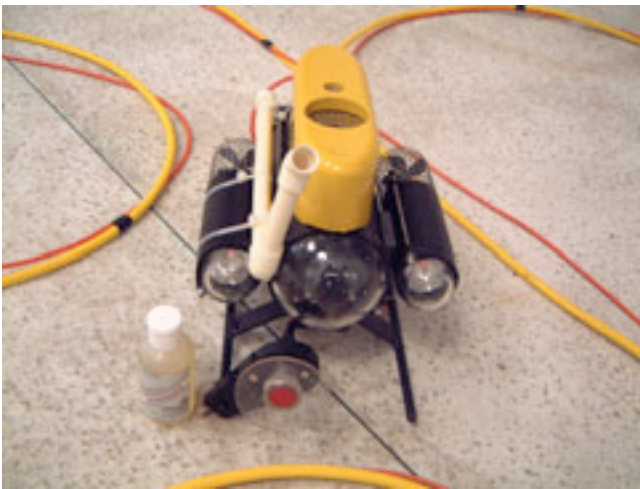
A CP probe, Cygnus IV Multi-Echo Ultrasonic Thickness Gauge and solid/liquid sampling trays were attached to the sub for data gathering.

VideoRay with overhead sampling tray as well as Cygnus IV Multi-Echo Ultrasonic Thickness Gauge attached. (Photo by Bob Christ)

VideoRay functioned as the delivery vehicle for a variety of instruments for taking measurements as well as gathering both solid and liquid samples. The most innovative of the modifications was the addition of a universal joint mounted to the skid of VideoRay to accommodate the Cygnus IV Multi-Echo Ultrasonic Thickness Gauge. Since the transducer had to be flat against the metal surface in order to gain an accurate measurement, the universal joint allowed for VideoRay to pivot with the thrusters operating to gain a solid fit while allowing the transducer head to fit flat against the surface.

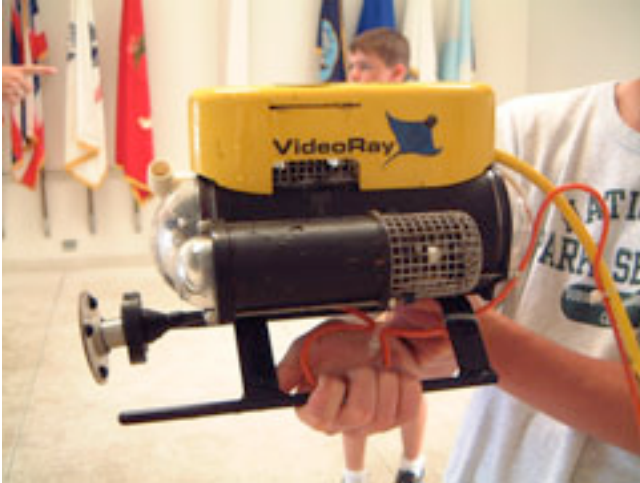
VideoRay with universal joint for mounting of Cygnus IV gauge (Photo by Bob Christ)

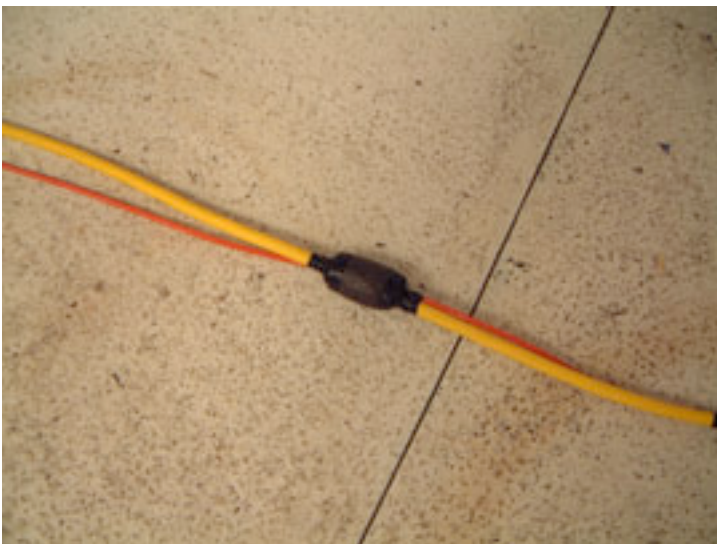
Tapered float on junction of instrument cable attachment to VideoRay tether (Photo by Bob Christ)

We found quickly that the best method to penetrate deep into the wreck was first to pull tether down a hallway or breezeway then survey back towards the penetration point. VideoRay made best progress with no more than 2 turns before reaching the extent of the penetration. The best method was to pass the area of interest (cabin, work area or room) until the necessary tether was pulled then come back to survey the area. There were several tether snags which were eventually cleared. These included a snag on the air duct in the ceiling due to a [buoyancy] light tether, a catch on a table due to a heavy tether and a difficult tether snag due to attachment of the dissolved oxygen probe cable attached to VideoRay's tether. The fix for the tether buoyancy problem with the heavy cable attachment was tapered floats.
