Why do we carry out Flooded Member Inspection?

Case study - Tracerco FMI Ensuring results are right first time

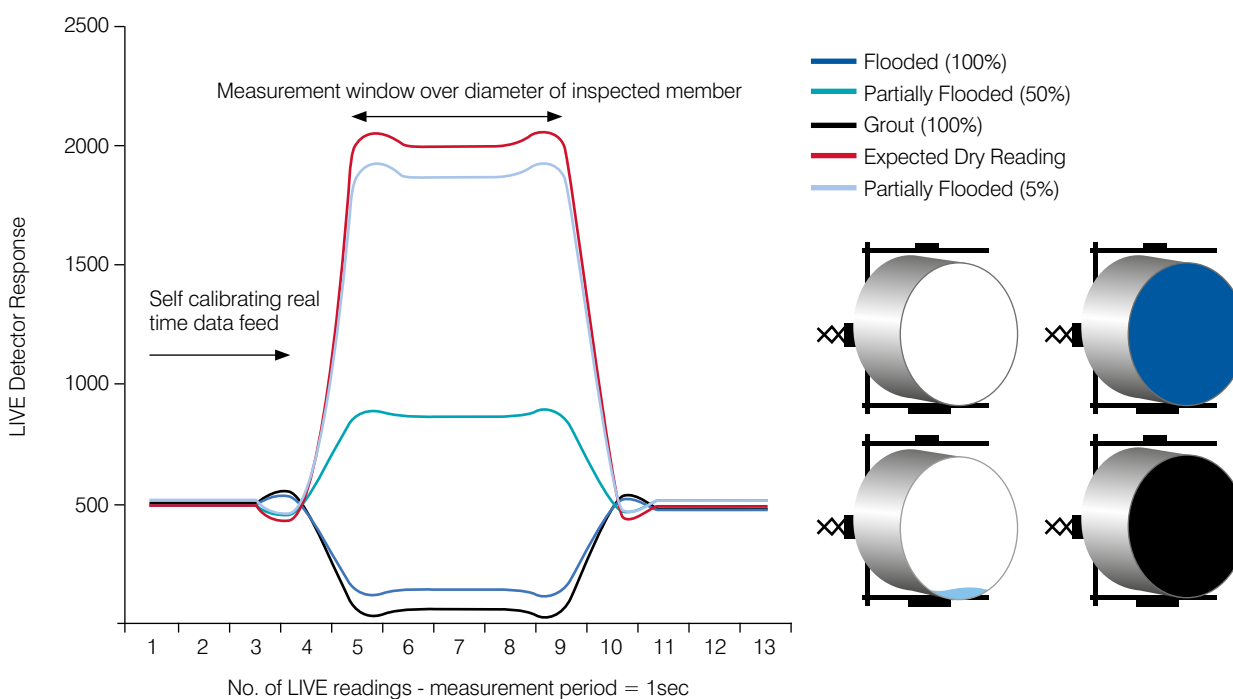
Graph showing expected signal for a Dry, Flooded, Partially Flooded and Grouted member

- Partial Flooding: <5% of water ingress
- Grouted members: (full or partial)
- Wall thickness differences: +/- 2mm
- Diameter differences: +/- 10mm
- Node thicknesses: +/- 5mm steel
- Flooding interface accuracy: +/- 20mm
